1. REPORT DATE		2. REPORT TYPE Viewgraphs		3. DATES COVERED	
4. TITLE AND SUBTITLE NDE R&D at NAWC		5a. CONTRACT NUMBER			
		5b. GRANT NUMBER			
		5c. PROGRAM ELEMENT NUMBER

NDE R&D at NAWC

**Naval Air Warfare Center, Aircraft Division
Patuxent River, MD
October 16, 2000**

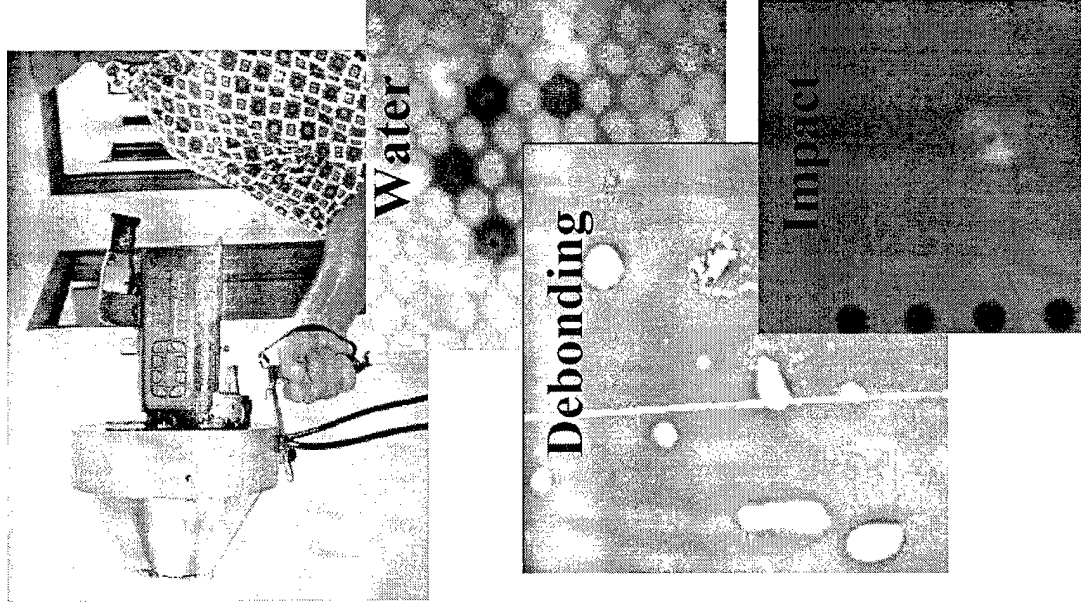
HAND-HELD PROTOTYPE IR NDT SYSTEM

- Problem: Rapid and reliable detection of hidden corrosion, impact damage, water entrapment.
- Solution: Development and Transition Infrared Thermography to I- and D- level maintenance programs
- Advantages (compared to ultrasonic inspection):
 - NO COUPLANT REQUIRED
 - WIDE AREA INSPECTION METHOD
 - INSENSITIVE TO CURVATURE
 - EASY TO INTERPRET
 - PORTABLE
 - NO SAFETY REQUIREMENTS.
- Cost Savings:
 - 30 ft²/min INSPECTION RATE (COMPARED TO 1 ft²/min FOR UT
 - CAN DETECT CORROSION WITH OUT PAINT REMOVAL
 - (DOES NOT GENERATE WASTE PRODUCTS)
 - CAN DETECT CORROSION INSIDE LAP JOINT
 - \$ 25M/Aircraft POTENTIAL COST SAVINGS FOR F-18 E/F OVER THE LIFE OF THE AIRCRAFT (Boeing Data)
- Transition Potential: P-3C, C-130, KC-135, F-18 C/D, JSF

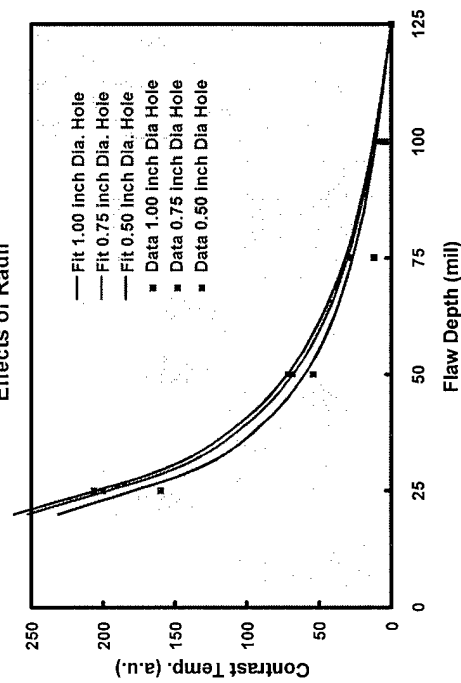
Effects of Radii

$$\Delta T_{\text{front}}(t) = \frac{Q}{\rho c} \cdot \frac{e^{-2 \frac{k_s t}{\rho c R^2}} - e^{-\frac{k_s t}{2 \rho c d(t_o - d)}}}{d \cdot \left(1 - \frac{4 \cdot d^2 \cdot (t_o - d) \cdot k_L}{R^2 \cdot t_o \cdot k_n \cdot t_o - d} + \frac{d}{t_o - d} \right)}$$

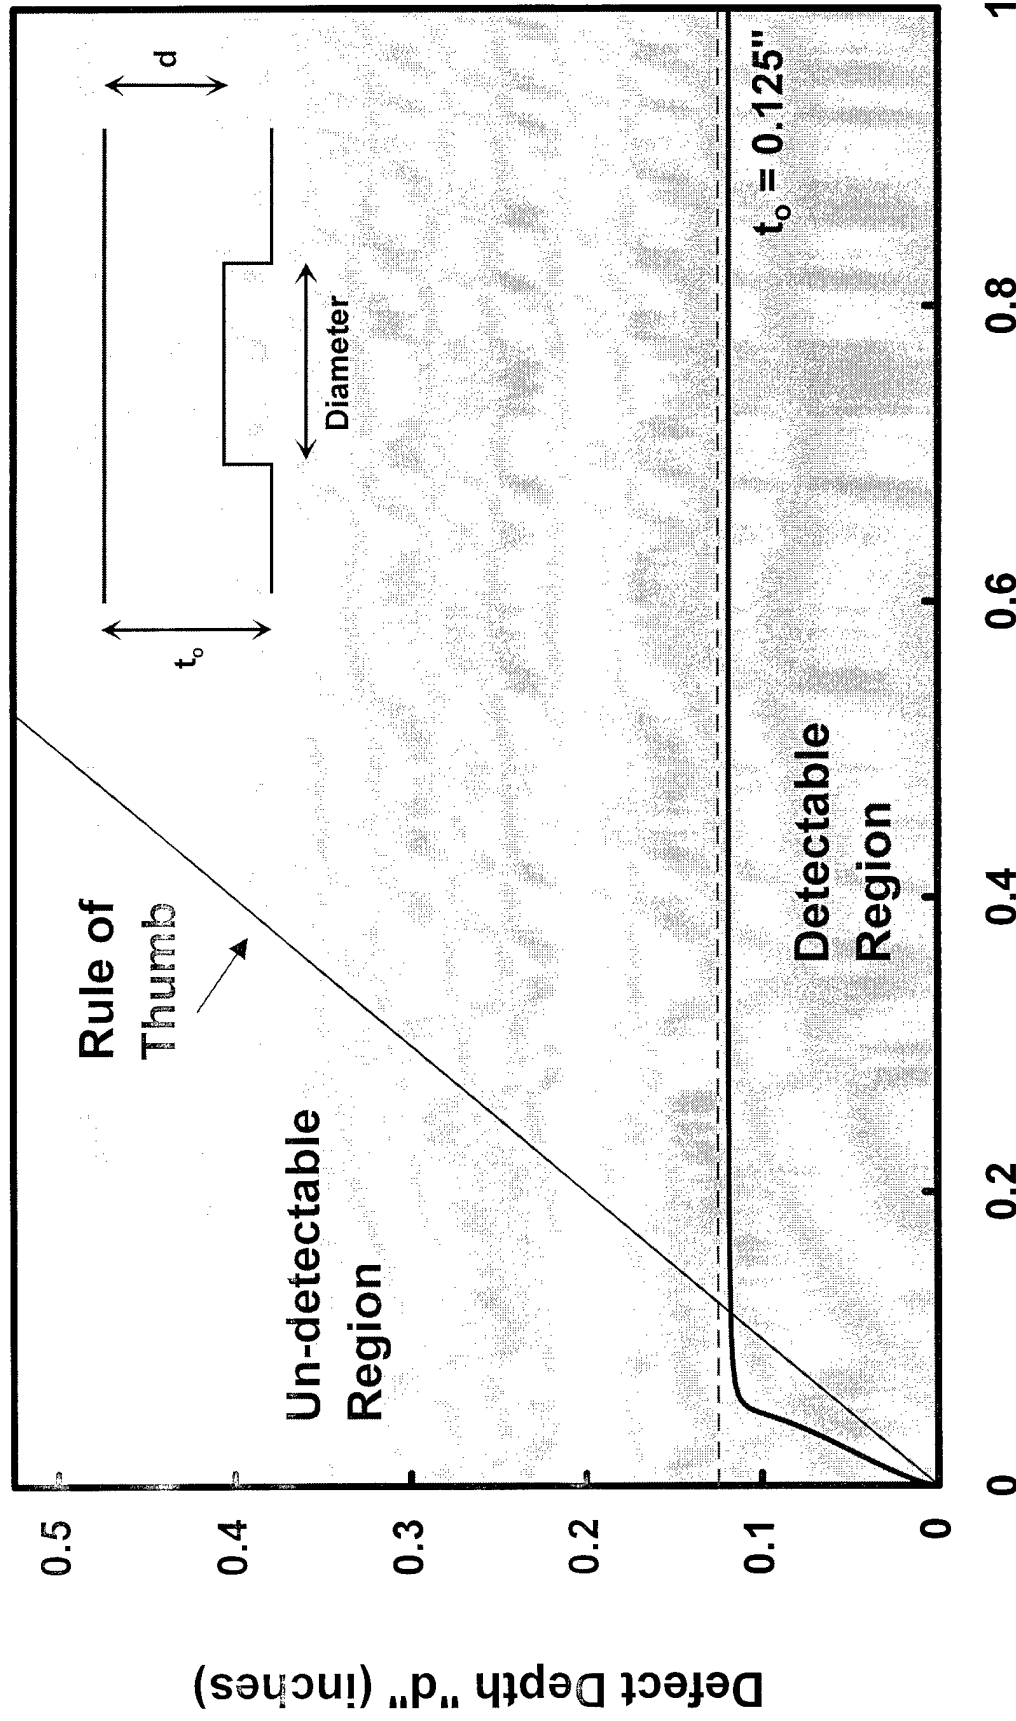
Depth of Resolution

Defect Diameter "2R" (inches)

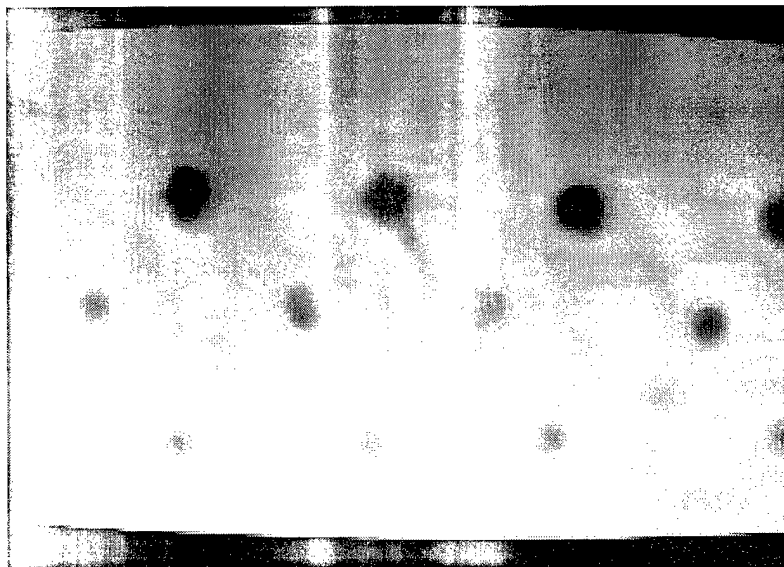
SAMPLES PREPARATION

R = 1/4" 3/8" 1/2" 1/8"

Experimental Parameters for Drops and Panels		
Al Thickness	Straw Diameter	Water Height
$t_o = 1/32"$	$D = 1/8"$	$d = 0"$
$t_o = 1/16"$	$D = 1/4"$	$d = 1/16"$
$t_o = 1/8"$	$D = 3/8"$	$d = 1/8"$
	$D = 1/2"$	$d = 3/16"$
		$d = 1/4"$

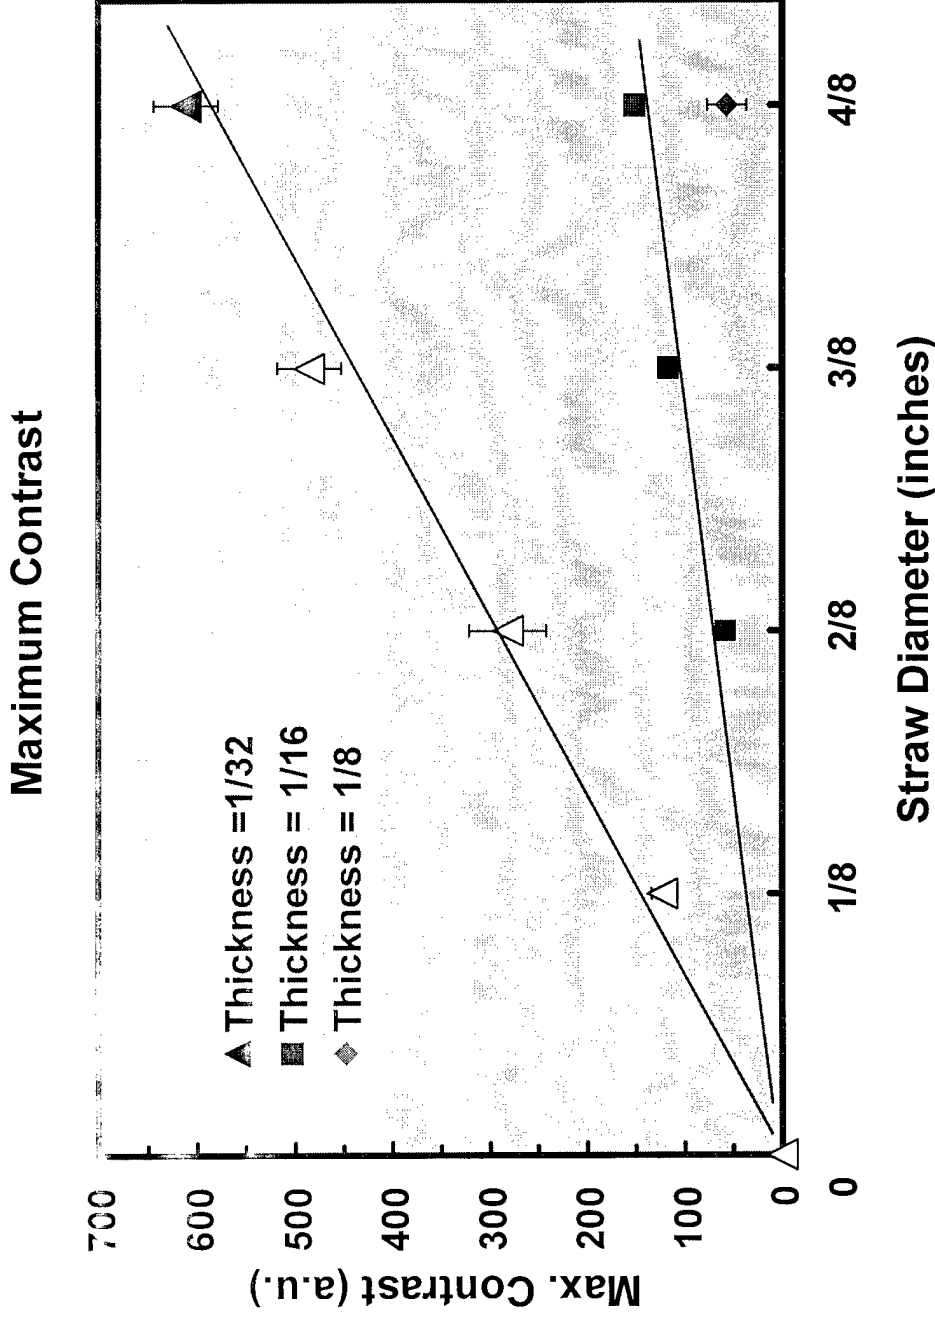
Experimental Data II

- The thinner the aluminum substrate the larger the contrast
- The smaller the straw diameter the smaller the contrast
- The amount of water in the straw does not affect the contrast (error bars small)

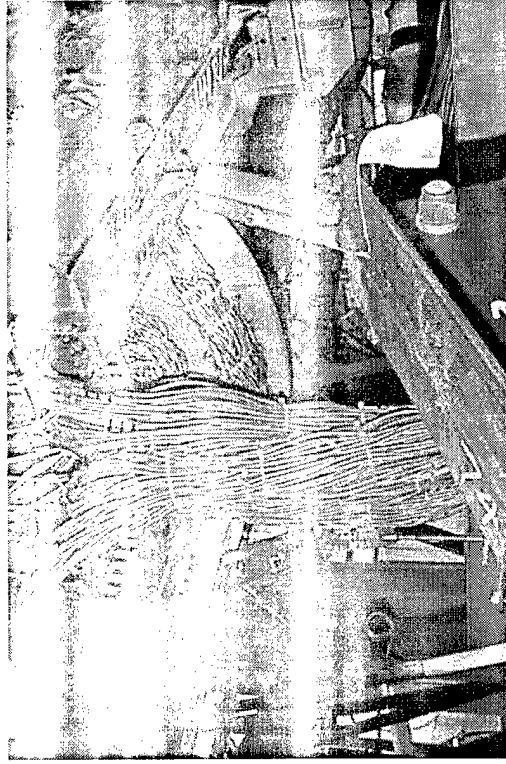
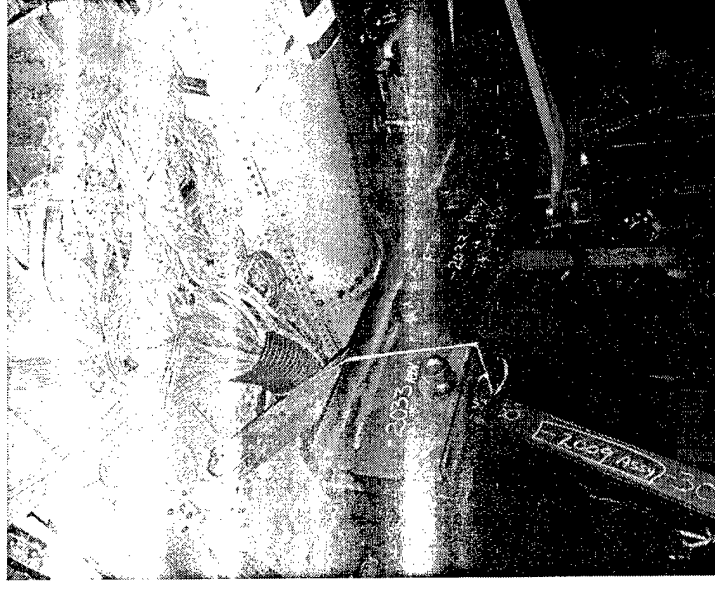
F-18 E/F Full Scale Fatigue Test

Wiring for strain sensor instrumentation during a full scale fatigue test of F-18 aircraft. Every sensor requires a minimum of two electrical leads. Each sensor requires a calibration file. Special care has to be taken to avoid EMI.

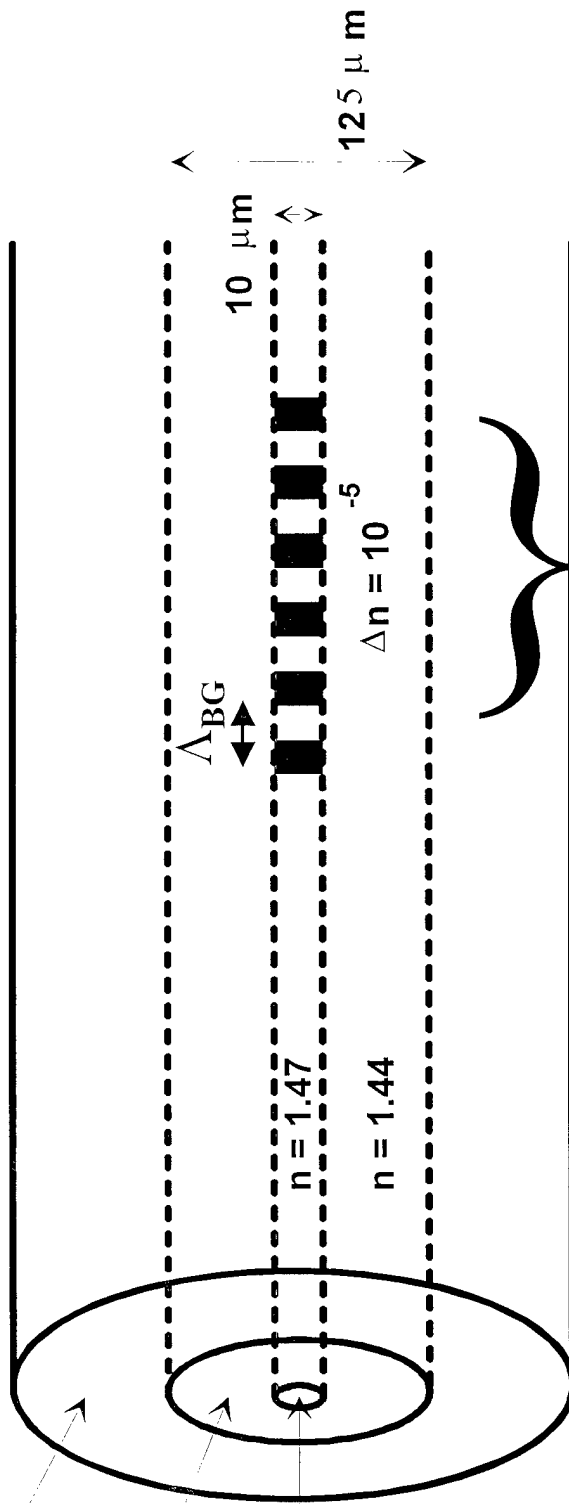
Optical Fiber Bragg Grating

POLYIMIDE
BUFFER
COATING

GLASS
CLADDING

GLASS
CORE

BRAGG GRATING

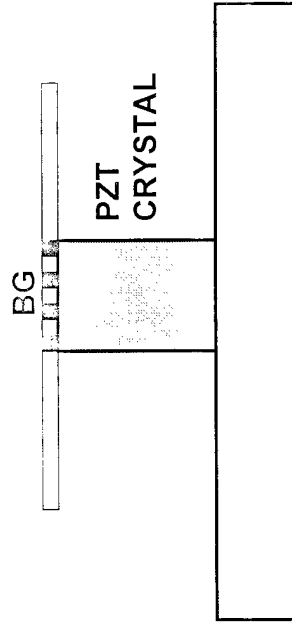
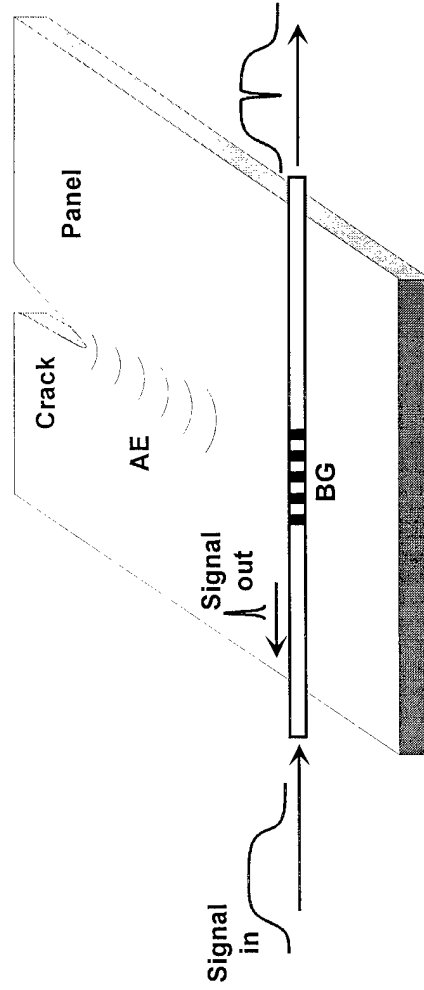
AE Sensitivity

- Acoustic Emission event detected with a single fiber-optic Bragg grating

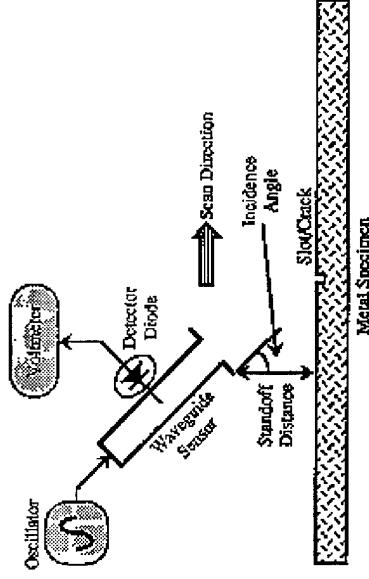
Pre-prototype 10 GHz Shipboard
CUP Detection System

- Measure material dielectric properties
- Modify the current CSU to microwave NDE model to include the effects of a coating and capability to identify corrosion sites and cracks within one instrument
- Design and prototype handheld instruments
- Conduct lab & field trial evaluations
- Refine design

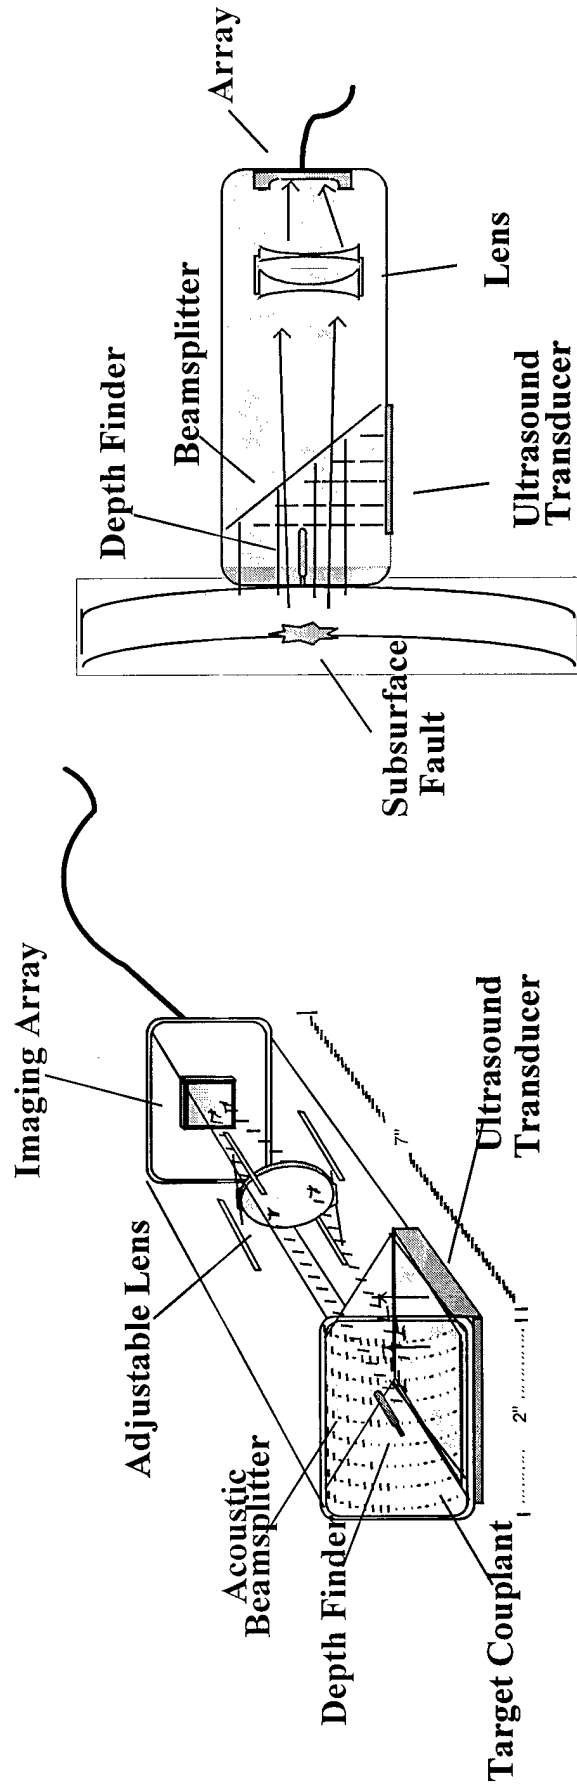
Liquid Filled Sound Wave Imaging Probe:

UT Imaging Concept

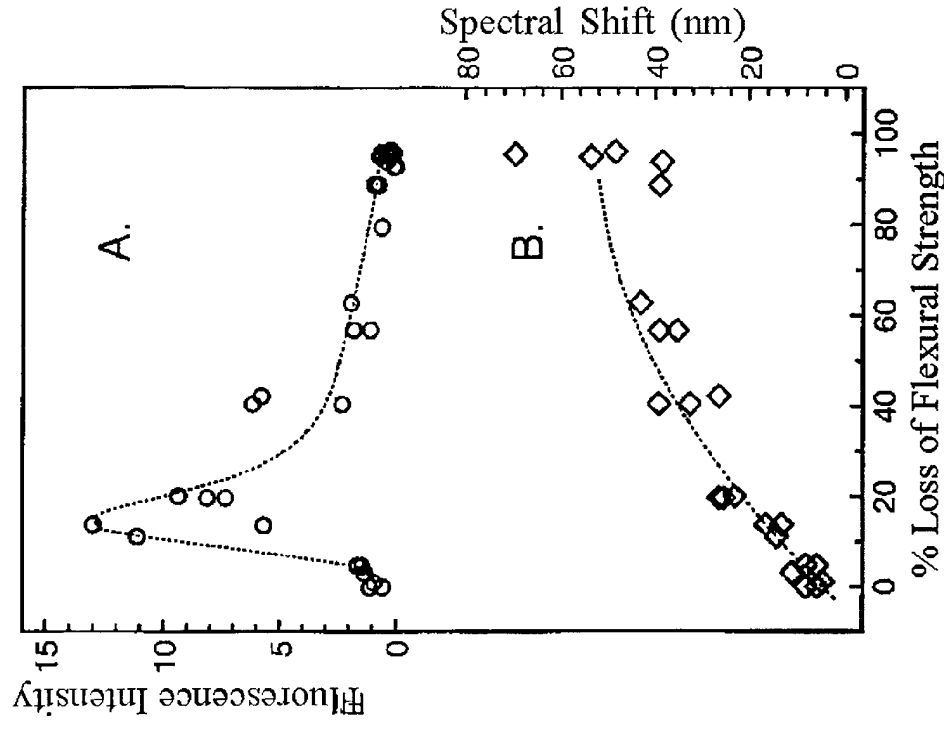
LIF Concept

- The composite is illuminated using a laser
- The laser light excites electrons to higher energy states
- When the electrons return to their natural state, light is emitted at a longer wavelength (fluorescence)
- The spectrum of the fluoresced light is extremely sensitive to variations in material properties
- Previous work has demonstrated that the fluorescent spectrum changes as organic matrix composite materials are subjected to heat

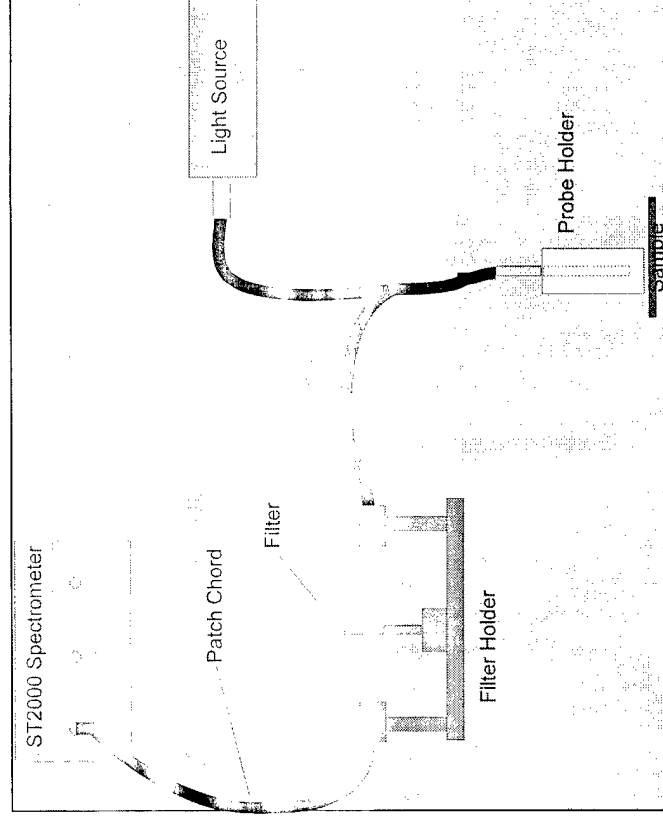
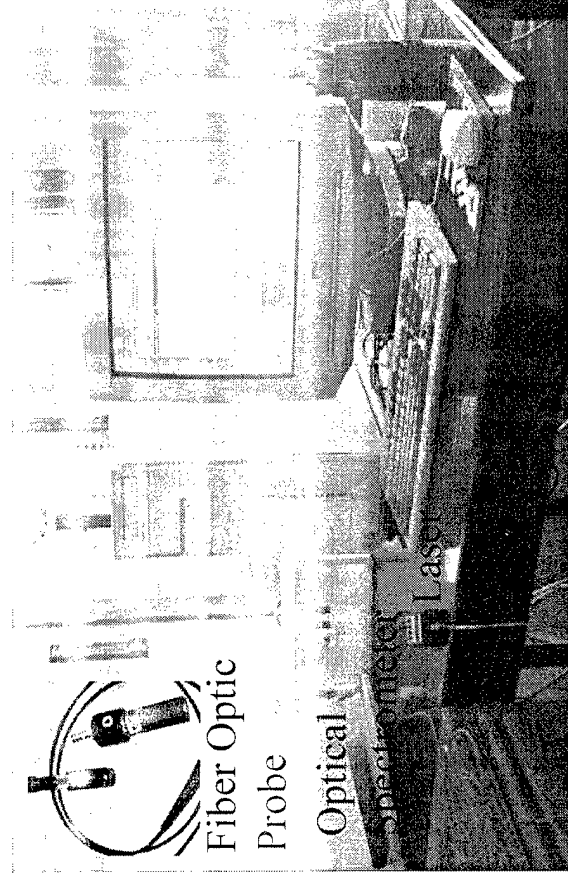
Portable LIF Measurement Concept

- The portable LIF measurement concept is identical to that of the imaging system except the measurements are made at a single point
- A small laser is used in conjunction with a fiber optic emitting and receiving probe to illuminate the surface and gather the fluoresced light
- An optical spectrum analyzer is used to determine the wavelength at which the peak fluorescence occurs

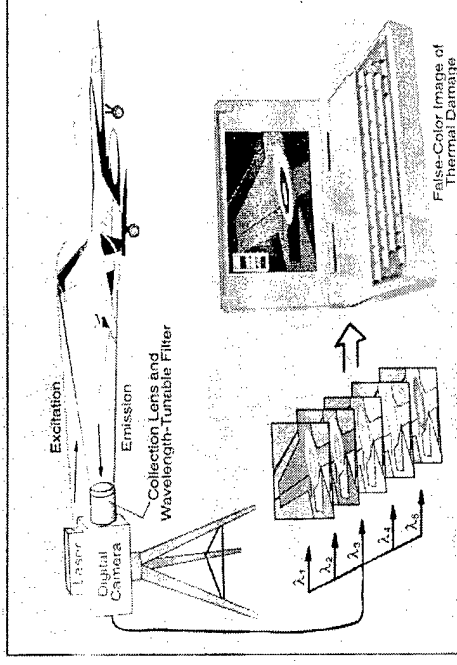
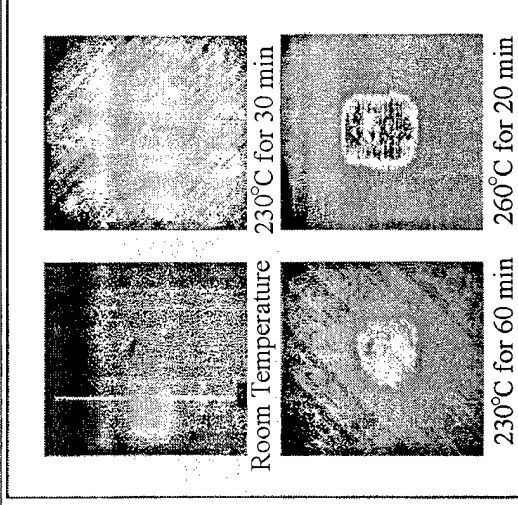
LIF Imaging Concept

- Using filters and a digital camera the fluorescent light can be captured and false colored images can be created
- Previous work demonstrated the feasibility of creating intensity-based images within a narrow (30nm) spectrum
- Current work involves analyzing the entire fluorescent spectrum and creating images based on the wavelength at which peak fluorescence occurs
- Spectrum analysis is accomplished using an acousto-optical tunable filter

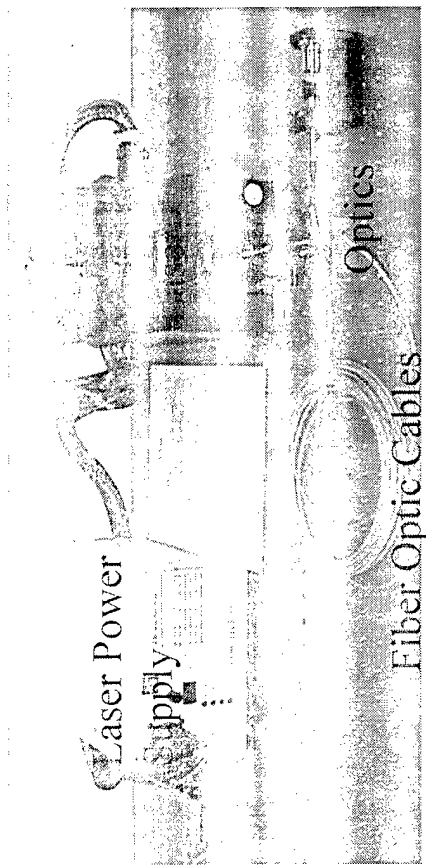
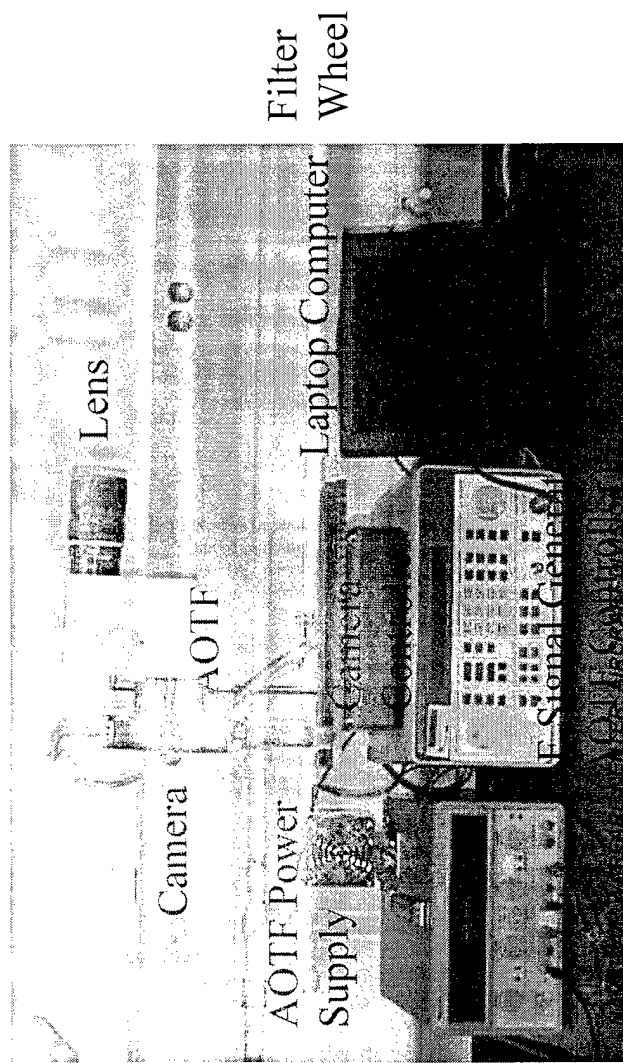
LIF Imaging System Configuration

- AOTF functional and operation successfully demonstrated
- Laser illumination successfully demonstrated
- Computer control software module developed for the AOTF
- System fully integrated and demonstration of imaging at different wavelengths completed
